LIGHTNING STRIKE REPORT -
ESCANABA GENERATING PLANT AND DISTRIBUTION SYSTEM
MAY 14, 2007, AND AUGUST 28, 2007

Michael A. Furmanski
Electric Superintendent
City of Escanaba
December 7, 2007

Subject: Unit 1 Generator Winding Damage from Lightning Strike

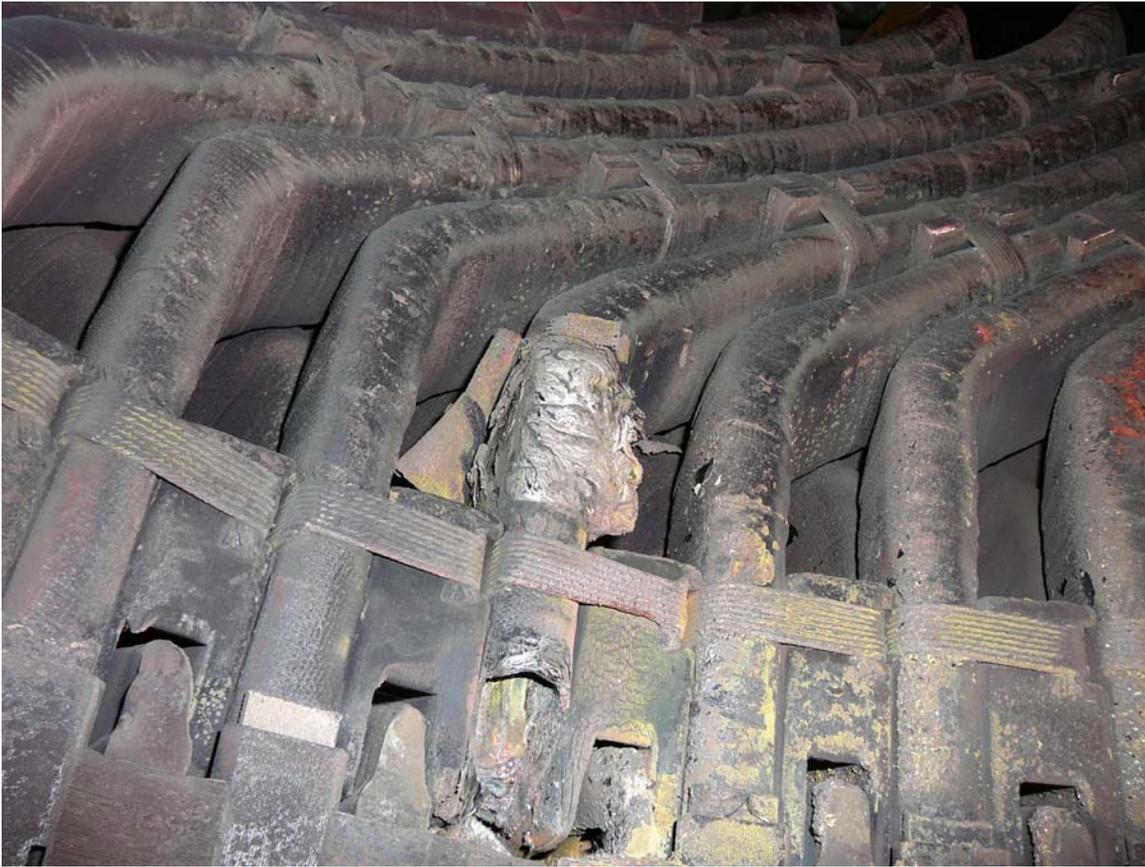
Attachment #1 – photo showing burnt windings on #1 generator stator

On May 15, AIMS, Inc of Milwaukee, WI was brought on-site to assess the damage to the #1 generator. They found a dead short on the B phase and a partial short on the C phase. The generator's rotor was removed on May 22, 2007 and damaged turns were found in the stator. Attachment #1 is a picture of the damaged turns.

"The failure occurred in slot 12, top coil half. The coil failure was at the TE core end. This coil is the B1 main phase coil (this unit has two parallel circuits). The observed damage is indicative of a turn failure. The coil has five turns (see attached photo). As the turn insulation fails current is routed through the shorted area cause severe overheating. As each turns fails it causes damage to the adjacent turn insulation creating a "cascading effect" of turn failures. The generated heat causes destruction of the ground wall insulation resulting in failure to ground, in this case the stator core.

It is possible that a lightning strike in the yard caused current to feed back into B-phase damaging the turn insulation precipitating into a turn failure in the phase coil leading to severe overheating causing a ground wall insulation failure. Additionally, insulation and shorting damage was observed in the B-phase generator cable between the generator and the phase connection cabinets (see attached photo). This failure was probably simultaneous to the winding failure.

Requests for Proposals to repair the turns in the stator of #1 generator were sent to various repair shops a within days of May 22, 2007. Included in the scope of work was an order to rebuild or repair the rotor, which had had some shorted turns for a few years. The rotor's condition did not require immediate attention prior to the lightning strike and had been operating that way for quite some time. City staff along with the Plant Operator decided then that rotor repairs should be made in conjunction with the stator repairs so as to maximize down time repair opportunities.

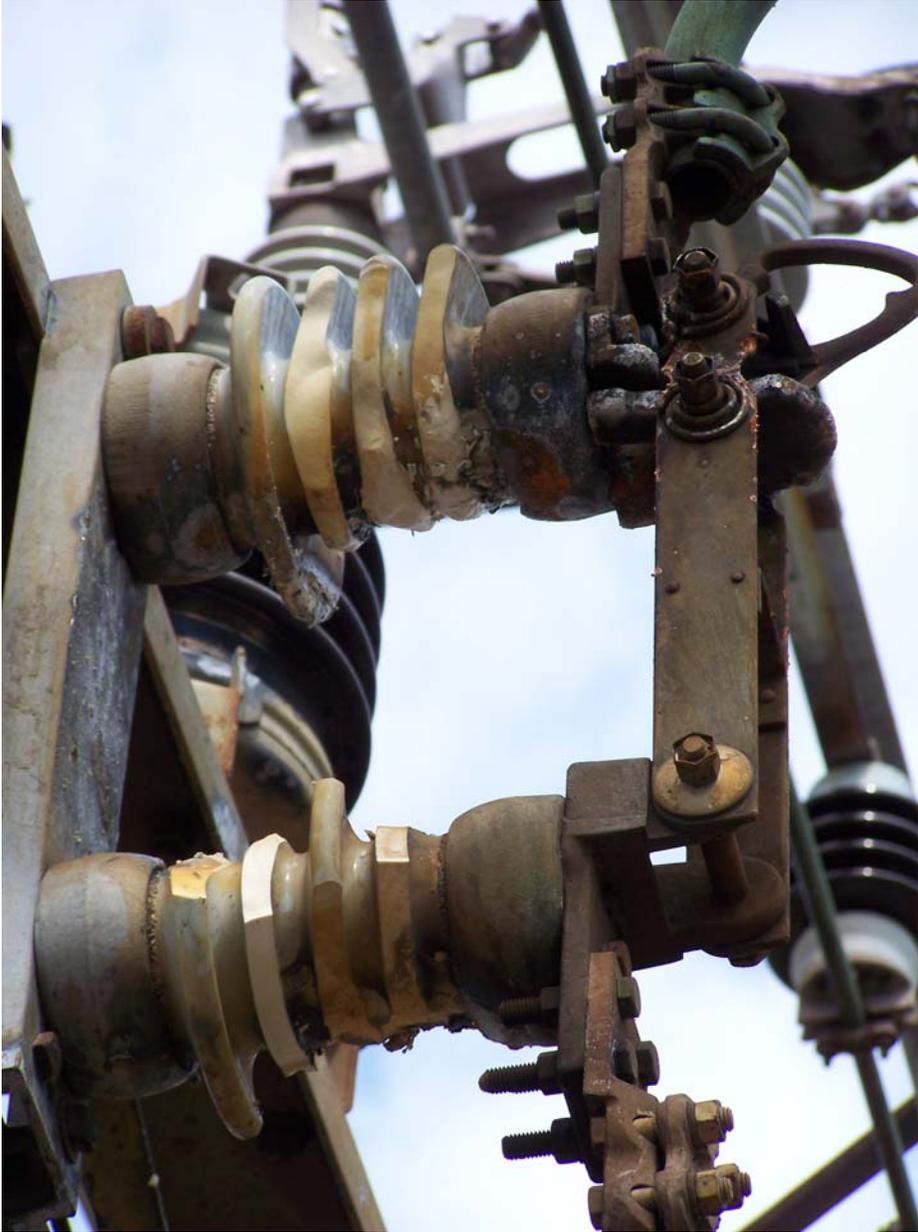
Attachment #2 – Switch damaged from the August 28, 2007 lightning strike

On August 29, there was a current imbalance identified on the #2 transmission line. Plant personnel were dispatched to look for problems in the power plant sub. All 6 bushing insulators on OCB 461 (the #2 line), along with the six (6) switches feeding into and out of OCB 461 were found to be broken and in very bad condition. These switches appeared to have been struck directly by lightning. This was verified by an eyewitness who saw lightning strike in the power plant substation and the plant go black early in the morning on August 28, 2007. Attachment #2 shows one of the damaged switches. It was decided to shut the #2 line down. City linemen opened switch #574 which is located near the Danforth Rd/Landfill Rd intersection. When this switch was opened, a very noticeable, sustained buzzing came from a switch located near OCB 461. UPPCO substation personnel were called in to do a thermal scan of this area. The arcing switch was not any hotter than the surrounding equipment. The 6 switches and OCB 461 were taken out of service on September 2. Three (3) new switches were installed during this outage.

- 1.2 The strike which damaged switchgear in the T&D Yard happened when strong sequential lightning strokes (three within less than one second) attacked the area. Switches failed due to overloading or overheating or both.

In early November, the bushings for OCB 461 were replaced as well as the other 3 switches. Another shut down was required to tie OCB 461 back into the #2 transformer. This shutdown occurred on December 1 which put things back to normal with both transmission lines feeding into the main bus at the power plant sub.

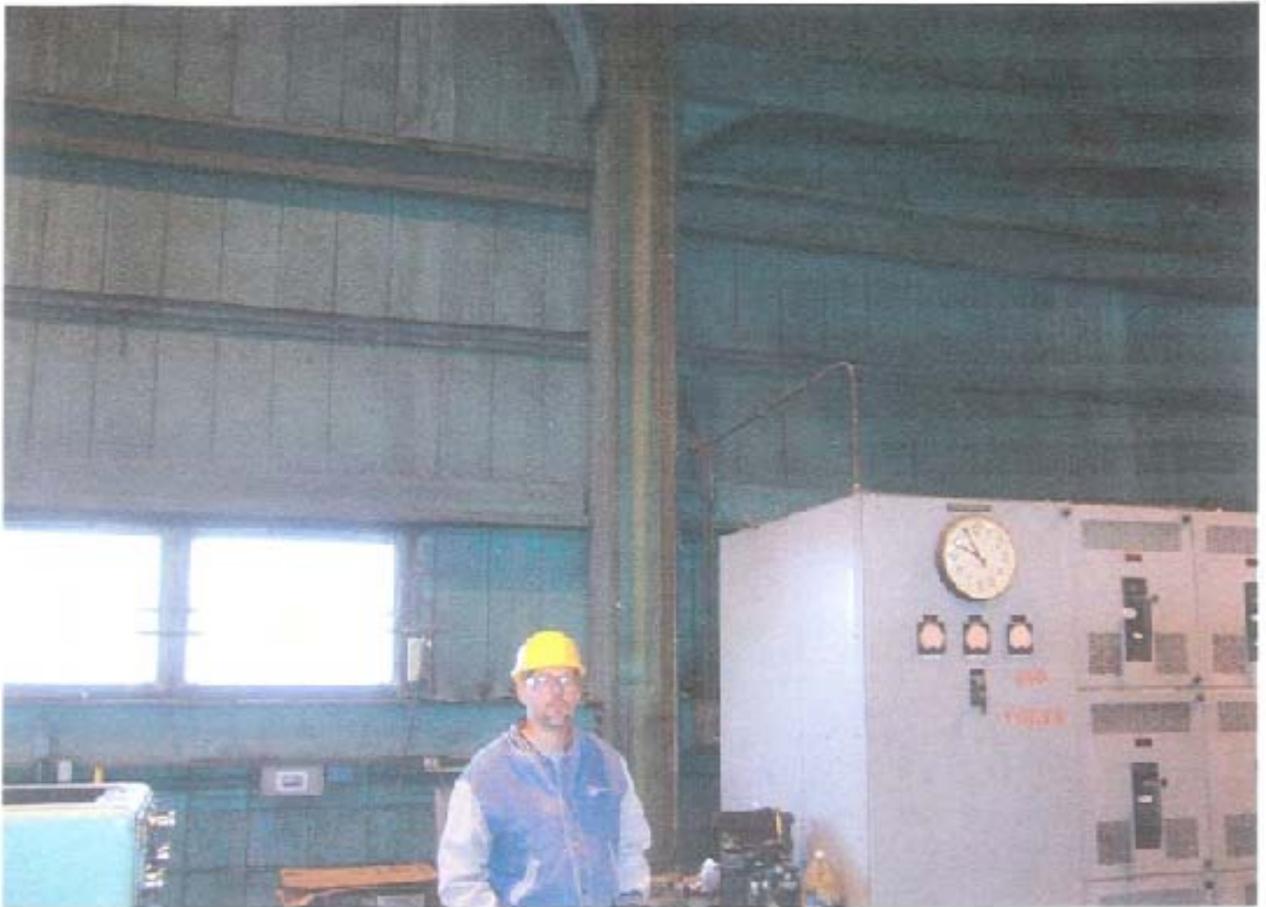
3.2.1 A unusually strong 77 kA positive lightning event attached first to a roof-mounted antenna pole. Lightning then traveled via building steel columns seeking parallel paths to electrical earth. The nearby motor control center (MCC) was affected as were many downstream circuits. Generator windings were damaged during this "least impedance to ground" event. Had the antenna pole not been present, lightning probably would have attached to the same area of the building anyway.

MCC next to Steel Beam, North Side Interior of Generator Plant. Lightning after striking the upper roof above this area created parallel paths in building steel. Induced voltages created havoc in the MCC and in downstream electrical circuits.

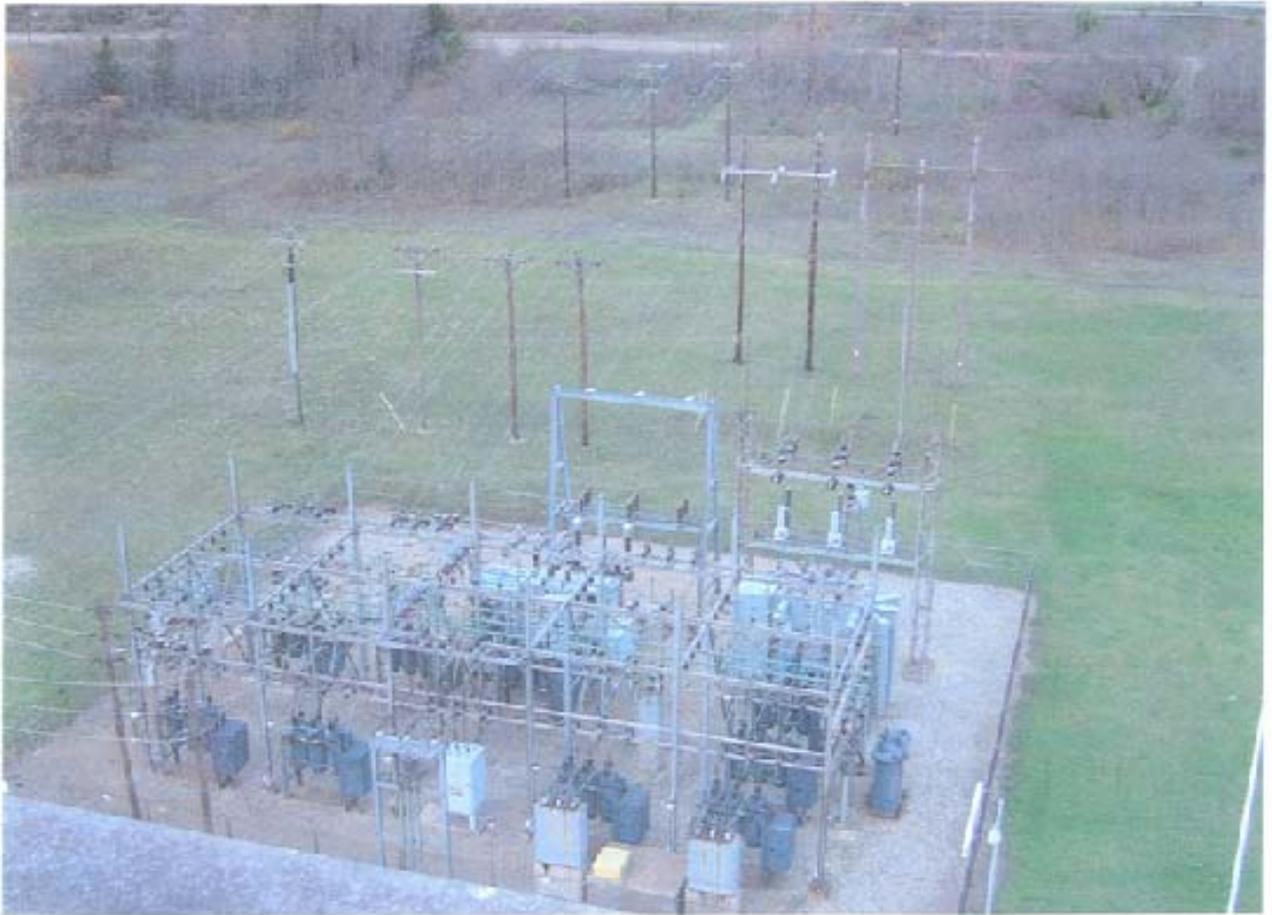
Protection of T&D Yard by OSW.

4.3.2 OSW geometries, by observation, appear to be inadequate to protect all T&D Yard equipment. At the time of plant construction IEEE 998 shielding angles were calculated to a 45 degrees "cone of protection." The most recent IEEE 998 standard is a more conservative 30 degrees angle or "shadow." The southern most side of the T&D Yard lacks protection. Some existing OSW should be elevated to achieve the 30 degrees angles.

Four existing OSWs from poles do not describe a 30 degree protective angle to all the equipment in the T&D Yard. Add OSWs to two southern most poles so as to provide coverage to southern part of T&D Yard.

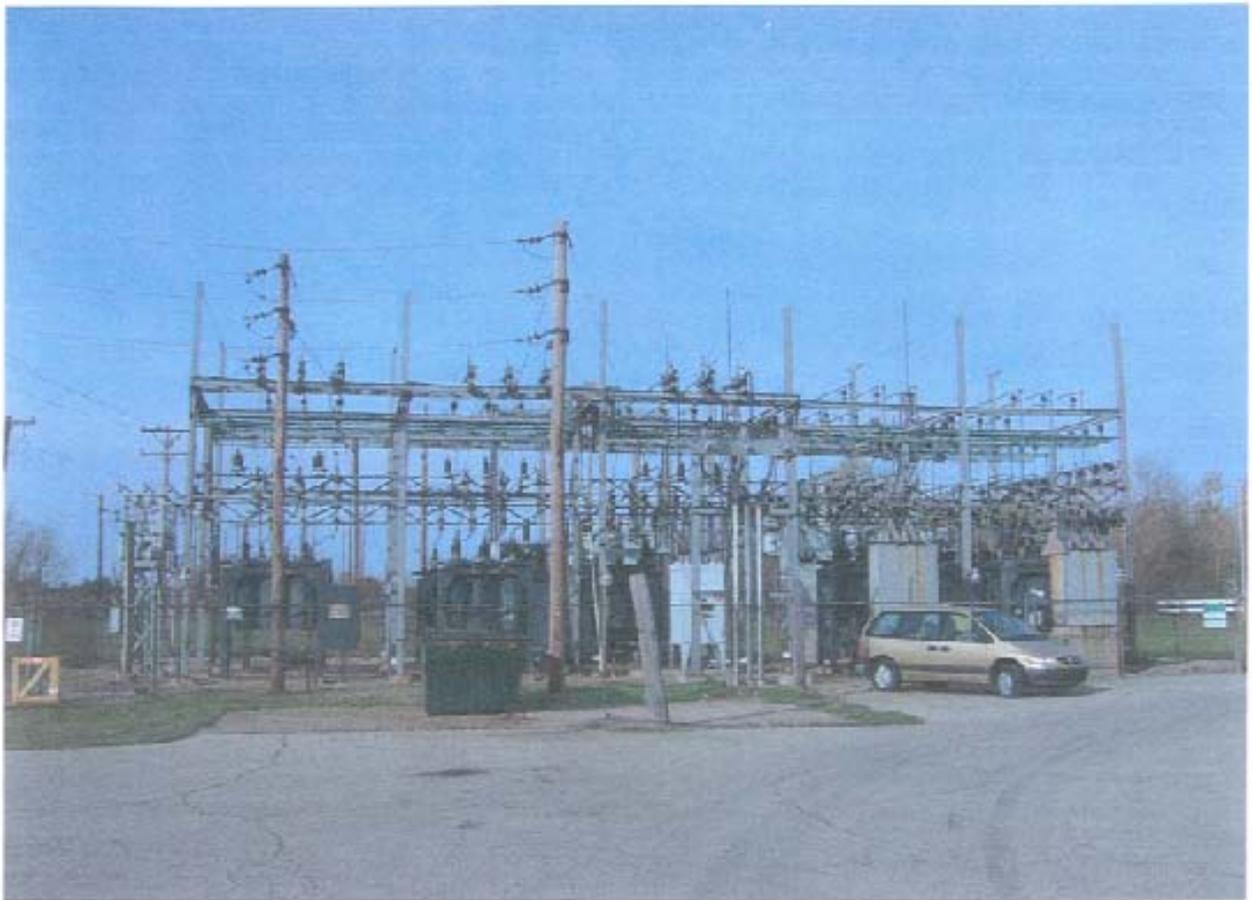
OSWs supported by Existing Steel Columns at East Side of T&D Yard. OSWs are not sufficiently tall to describe thirty degrees shielding angle. Install two inch dia. X 10 ft. tall steel poles to existing twelve I-beams so as to obtain required coverage.

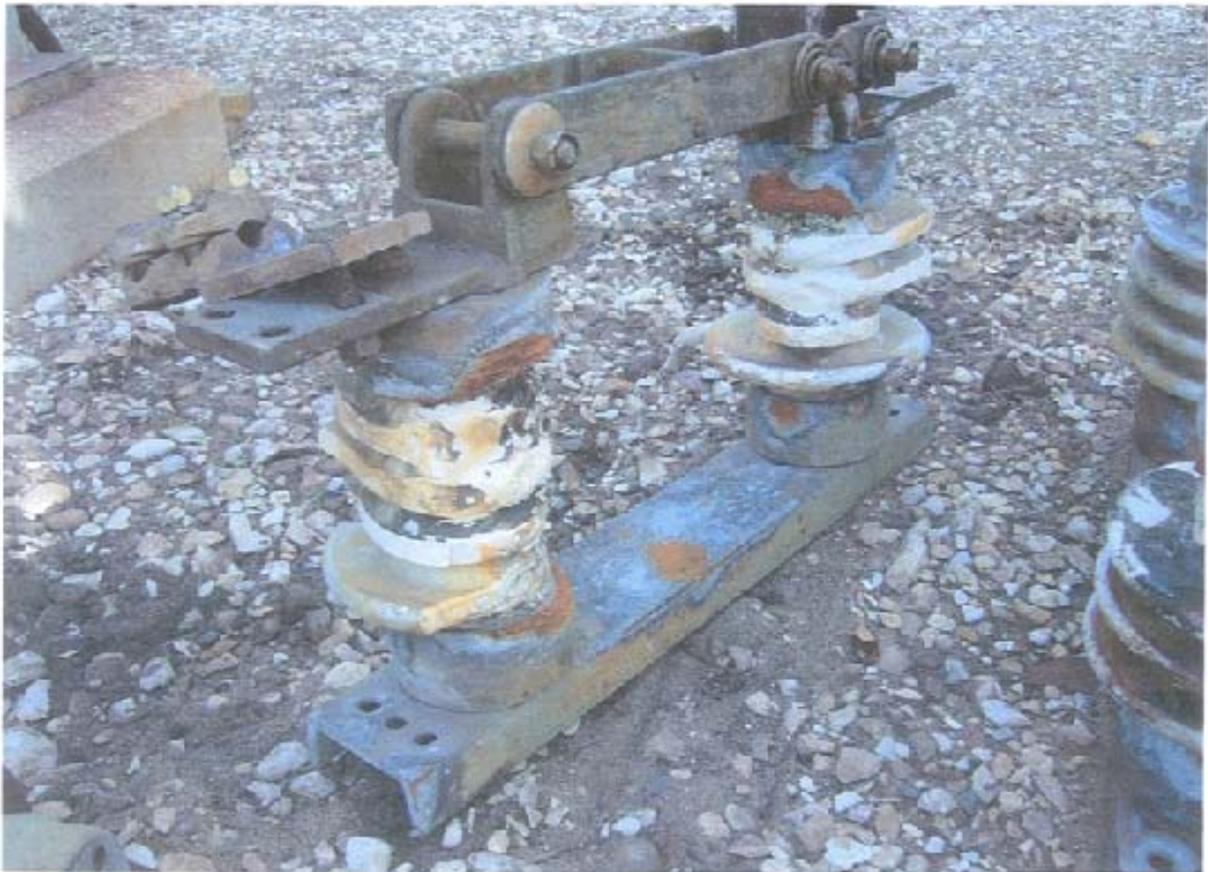
4.2 Opinion as to Reason for Damage. There are several circumstances (or combinations thereof) responsible: A) power fault follow-through caused melting of (unopened) switches; B) flashover from ionized air caused breakdown voltage lasting two seconds or more, leading to steady state "thermal runaway" where equipment generates heat faster than it can be dissipated; C) aging and/or pollution (coal dust?) on the switches as a factor leading to deteriorating efficiency; D) arrestors not sized correctly for line voltages; D) OSWs not providing sufficient zones of protection. Exact reasons remain inconclusive.

T&D Yard. Melted switches were caused when three lightning events attacked within one second of time.

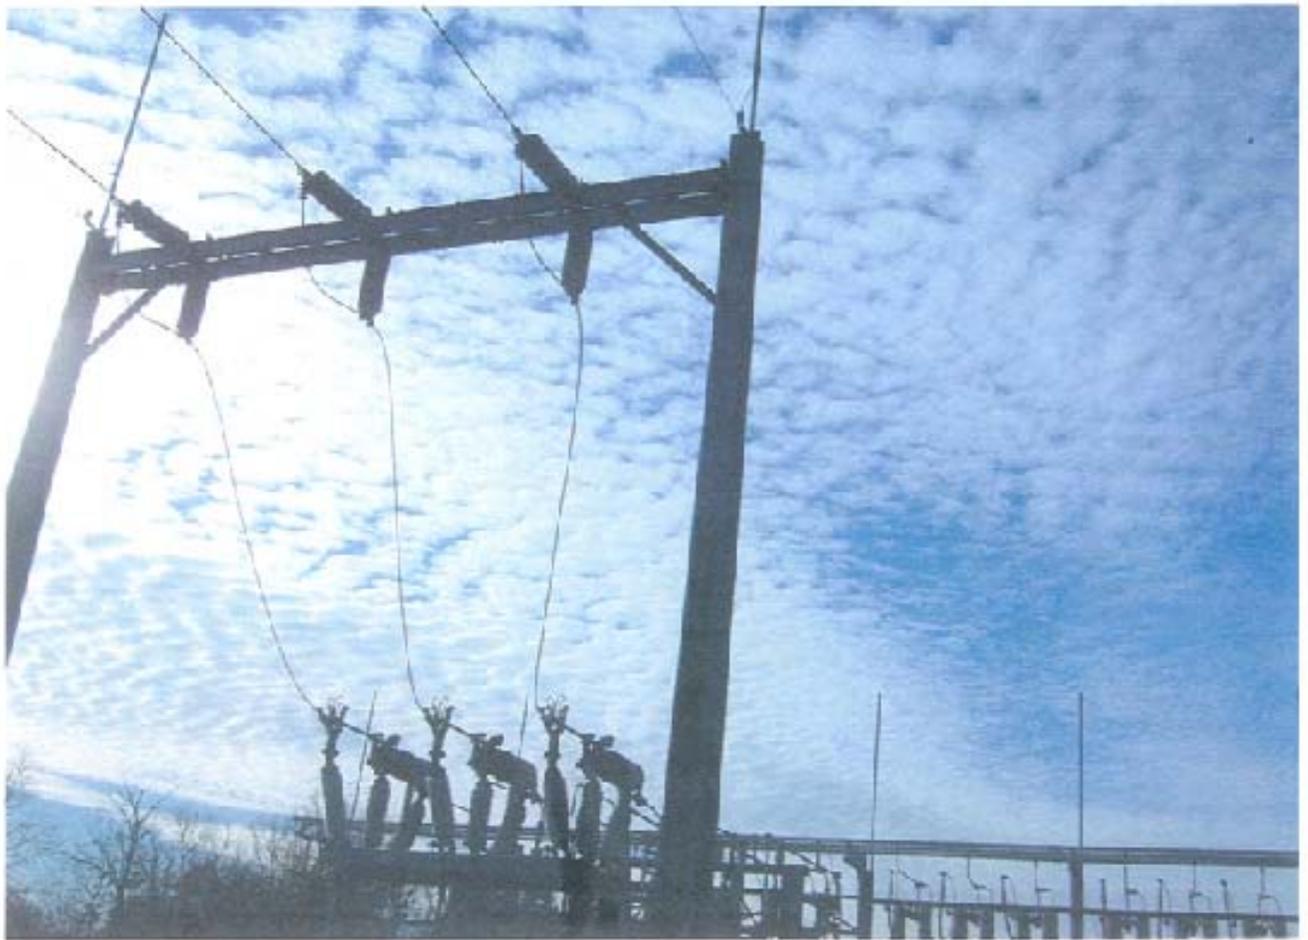
New West Yard. Overhead shield wires (OSW) do not “shadow” the transformer, leaving it vulnerable to lightning strikes. Install OSWs so as to describe a 30 degree zone of protection.

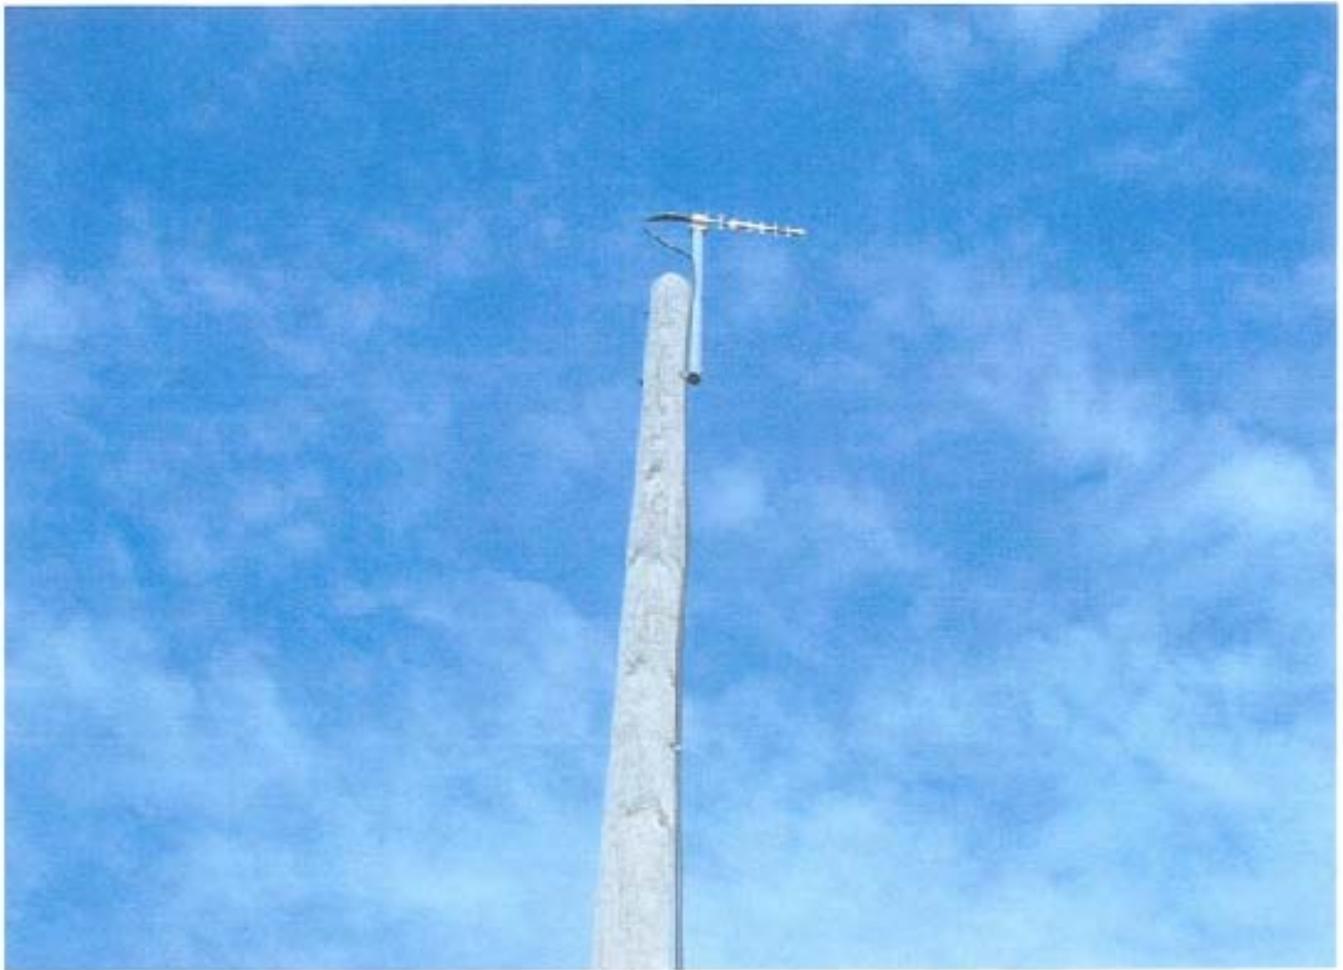
New West Yard. Steel antenna support pole must be grounded. Use bare No. 6 attached to opposite side of wooden pole from coaxial cable. Run bare ground wire to common earth reference.
