LIGHTNING STRIKE REPORT -
ESCANABA GENERATING PLANT AND DISTRIBUTION SYSTEM
MAY 14, 2007, AND AUGUST 28, 2007

Michael A. Furmanski
Electric Superintendent
City of Escanaba
December 7, 2007

Subject: Unit 1 Generator Winding Damage from Lightning Strike

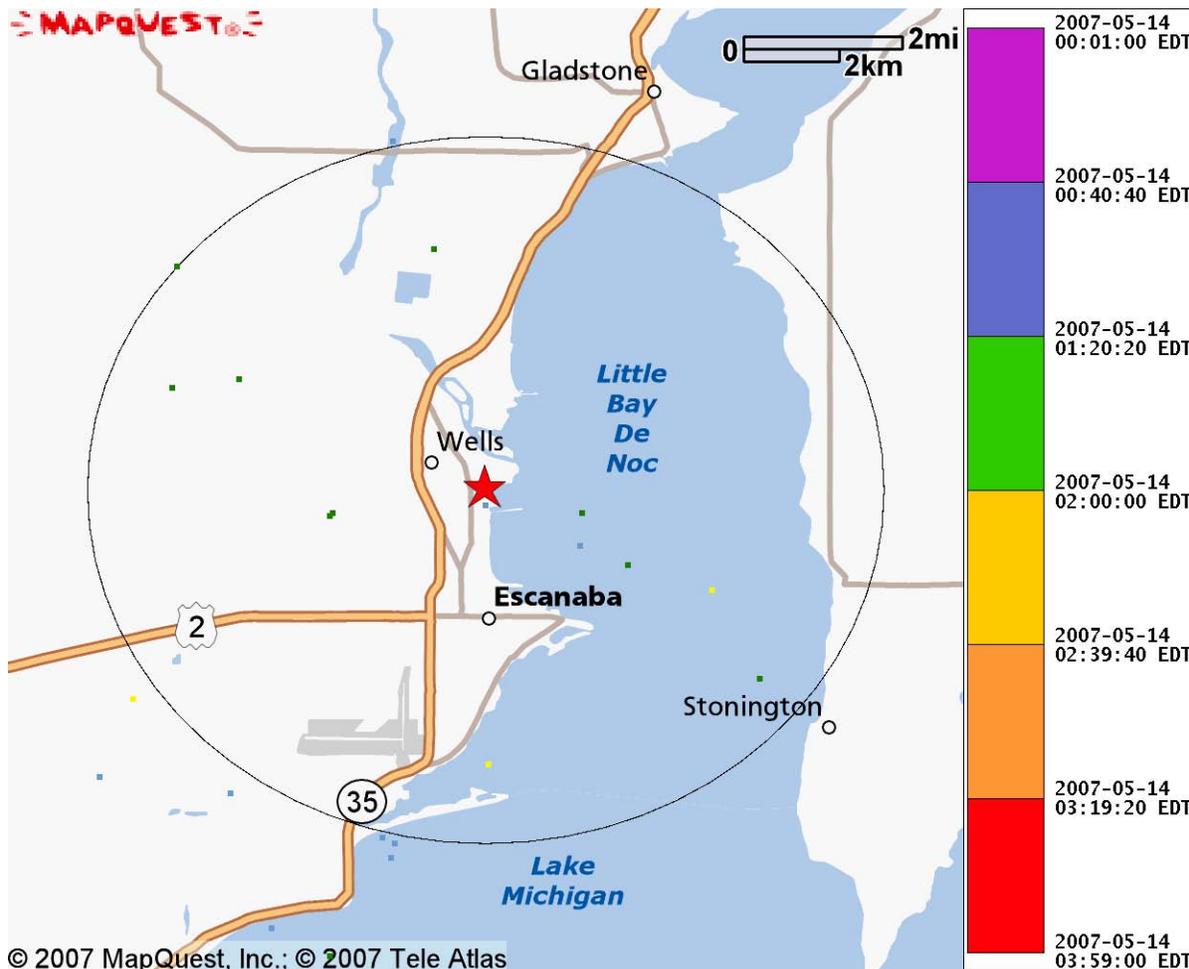
Location Points For Lightning Strokes

Report Title: city escanaba 2 Total Lightning Strokes Detected: 22 Lightning Strokes Detected within 5 mi/8 km radius: 13 Lightning Strokes Detected beyond 5 mi/8 km whose confidence ellipse overlaps the radius: 9 Search Radius: 5 mi/8 km Time Span: May 14, 2007 12:01:00 AM US/Eastern to May 14, 2007 03:59:00 AM US/Eastern

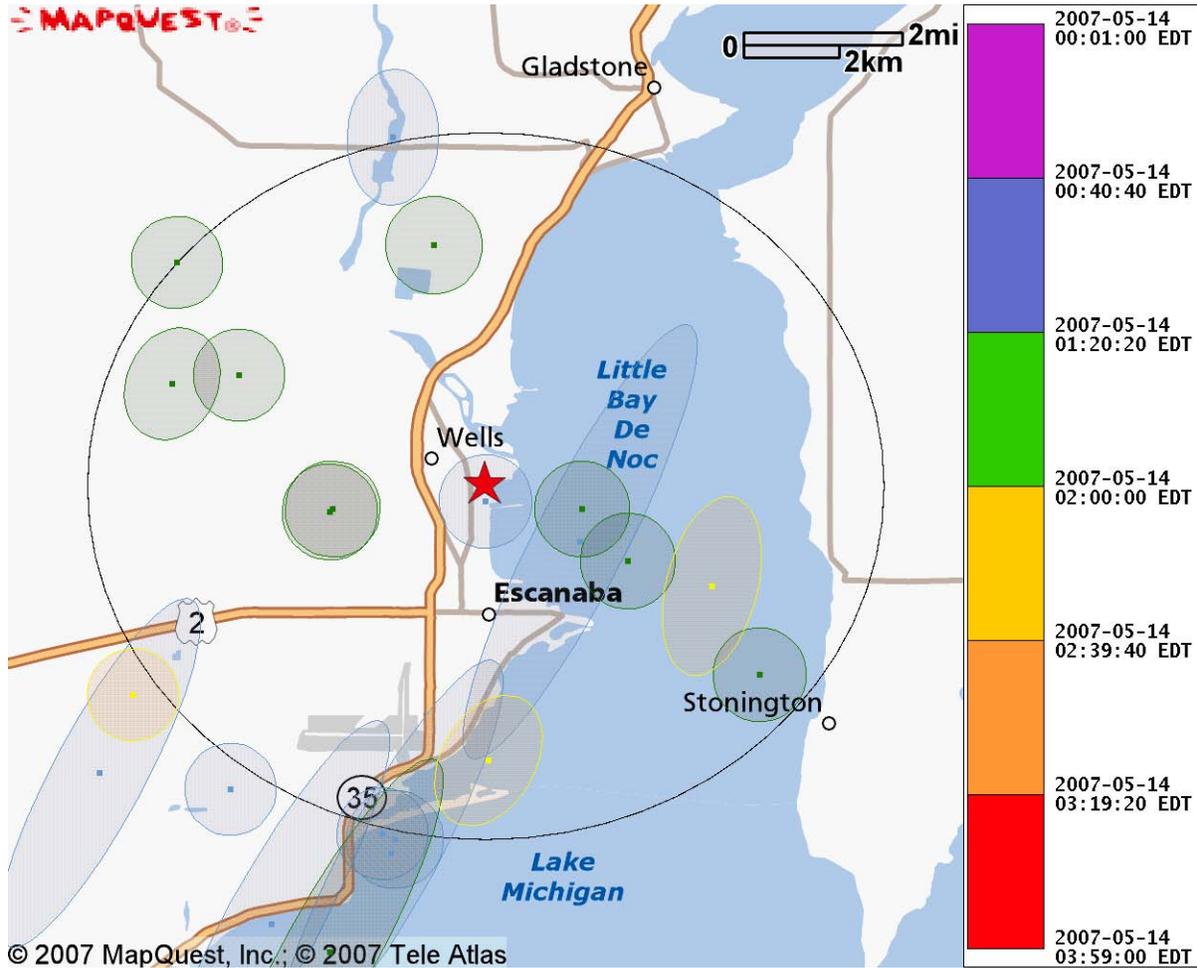
Confidence Ellipses For Lightning Strokes

Report Title: city escanaba 2 Total Lightning Strokes Detected: 22 Lightning Strokes Detected within 5 mi/8 km radius: 13 Lightning Strokes Detected beyond 5 mi/8 km whose confidence ellipse overlaps the radius: 9 Search Radius: 5 mi/8 km Time Span: May 14, 2007 12:01:00 AM US/Eastern to May 14, 2007 03:59:00 AM US/Eastern

Lightning data provided by Vaisala's NLDN® and/or Environment Canada's CLDN. Note: These ellipses indicate a 99% certainty that the recorded lightning event contacted the ground within the bounds of the ellipse.

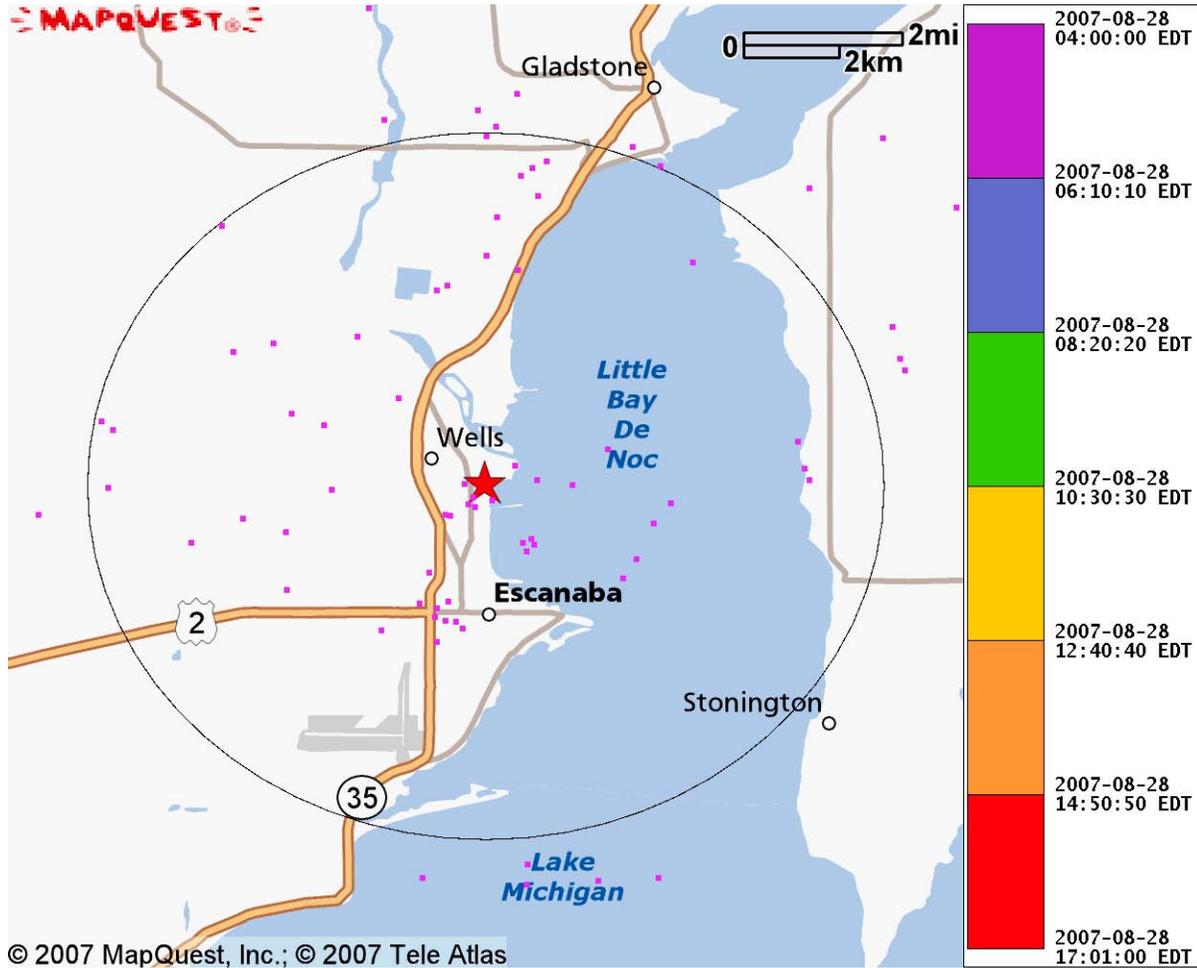
Location Points For Lightning Strokes

Report Title: City Escanaba Total Lightning Strokes Detected: 81 Lightning Strokes Detected within 5 mi/8 km radius: 58 Lightning Strokes Detected beyond 5 mi/8 km whose confidence ellipse overlaps the radius: 23 Search Radius: 5 mi/8 km Time Span: Aug 28, 2007 04:00:00 AM US/Eastern to Aug 28, 2007 05:01:00 PM US/Eastern

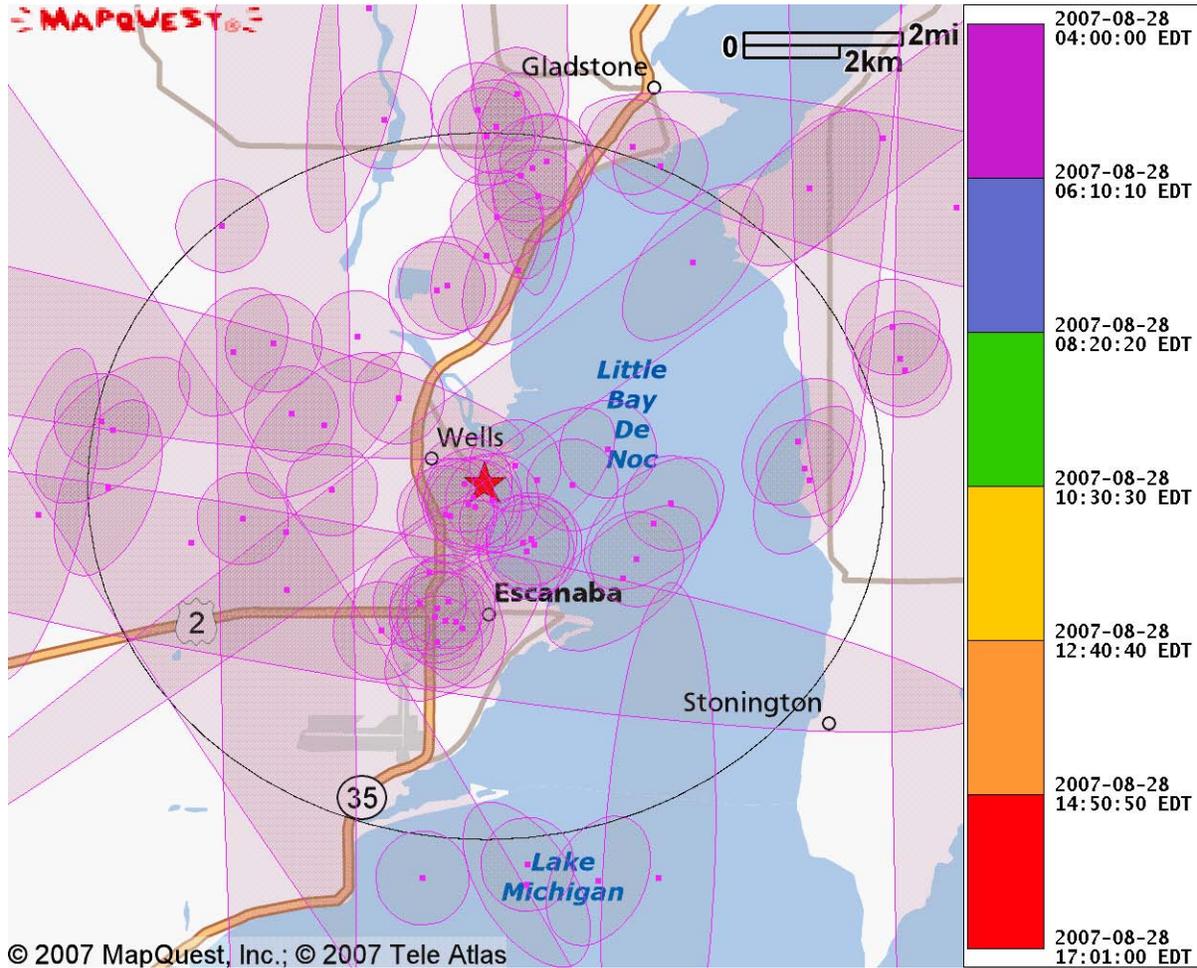
Confidence Ellipses For Lightning Strokes

Report Title: City Escanaba Total Lightning Strokes Detected: 81 Lightning Strokes Detected within 5 mi/8 km radius: 58 Lightning Strokes Detected beyond 5 mi/8 km whose confidence ellipse overlaps the radius: 23 Search Radius: 5 mi/8 km Time Span: Aug 28, 2007 04:00:00 AM US/Eastern to Aug 28, 2007 05:01:00 PM US/Eastern

Lightning data provided by Vaisala's NLDN[®] and/or Environment Canada's CLDN. Note: These ellipses indicate a 99% certainty that the recorded lightning event contacted the ground within the bounds of the ellipse.
