1700 Ludington Street

Escanaba Central Historic District

National Register of Historic Places
Continuation Sheet

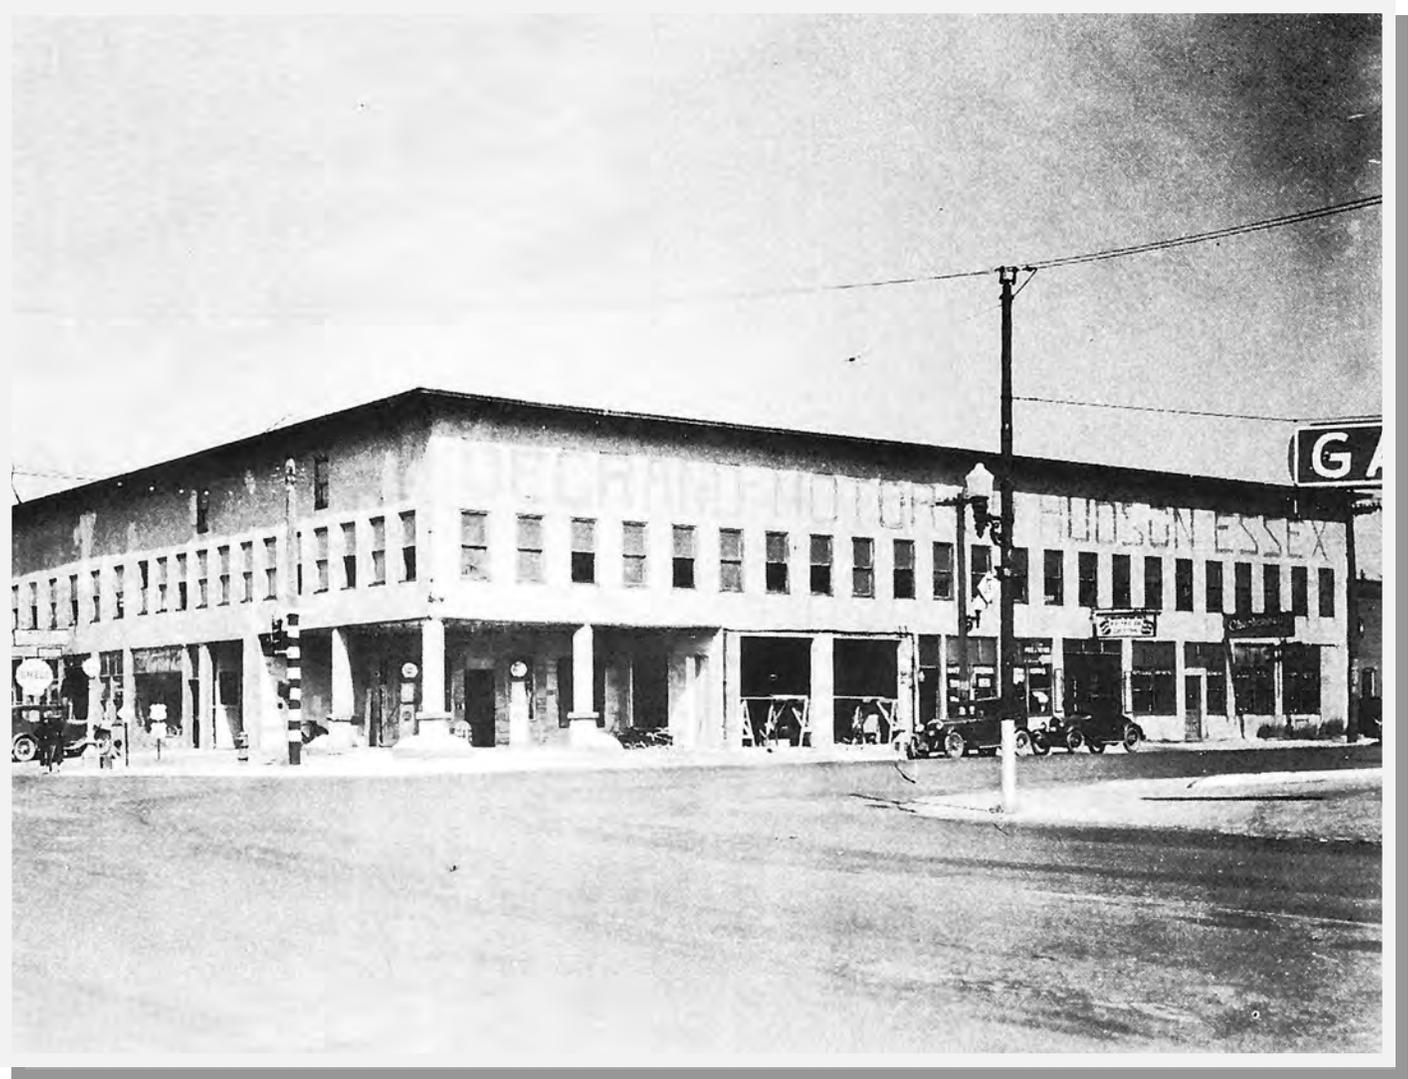
Historic Photo

1700 Ludington Street

Sanborn maps reveal this filling station was constructed after 1929 on a portion of the lots formerly occupied by the large DeGrand Motor Co. building (the same period when a large building was constructed at 1702-1704 Ludington that occupied the remainder of the DeGrand footprint). The 1929-50 Updates edition records a building with the distinctive footprint of the current building labeled Filling Station and Greasing. City directories reveal that 1700-1708 is the DeGrand Motor Co. in 1929. By 1937, the Ludington Shell Service filling station is addressed as 1700 Ludington, becoming Louie’s Service Station by 1941. In 1948 the DeGrand Oil Co. office and filling station is located here, while the 1953 edition places the DeGrand Oil Co. wholesale and Johnny’s Shell Service filling station at 1700. By 1959 1700 houses Snyder’s Shell Service gas station, continuing through 1963.
